Ice/Frost/Debris Assessment For Space Shuttle Mission STS-27R

(NASA-TM-102144) ICE/FROST/DEBRIS
ASSESSMENT FOR SPACE SHUTTLE MISSION
STS-27R, DECEMBER 2, 1988 (NASA) 200 p
CSCI 22B

ICE/FROST/DEBRIS ASSESSMENT
FOR
SPACE SHUTTLE MISSION
STS-27R
DECEMBER 2, 1988

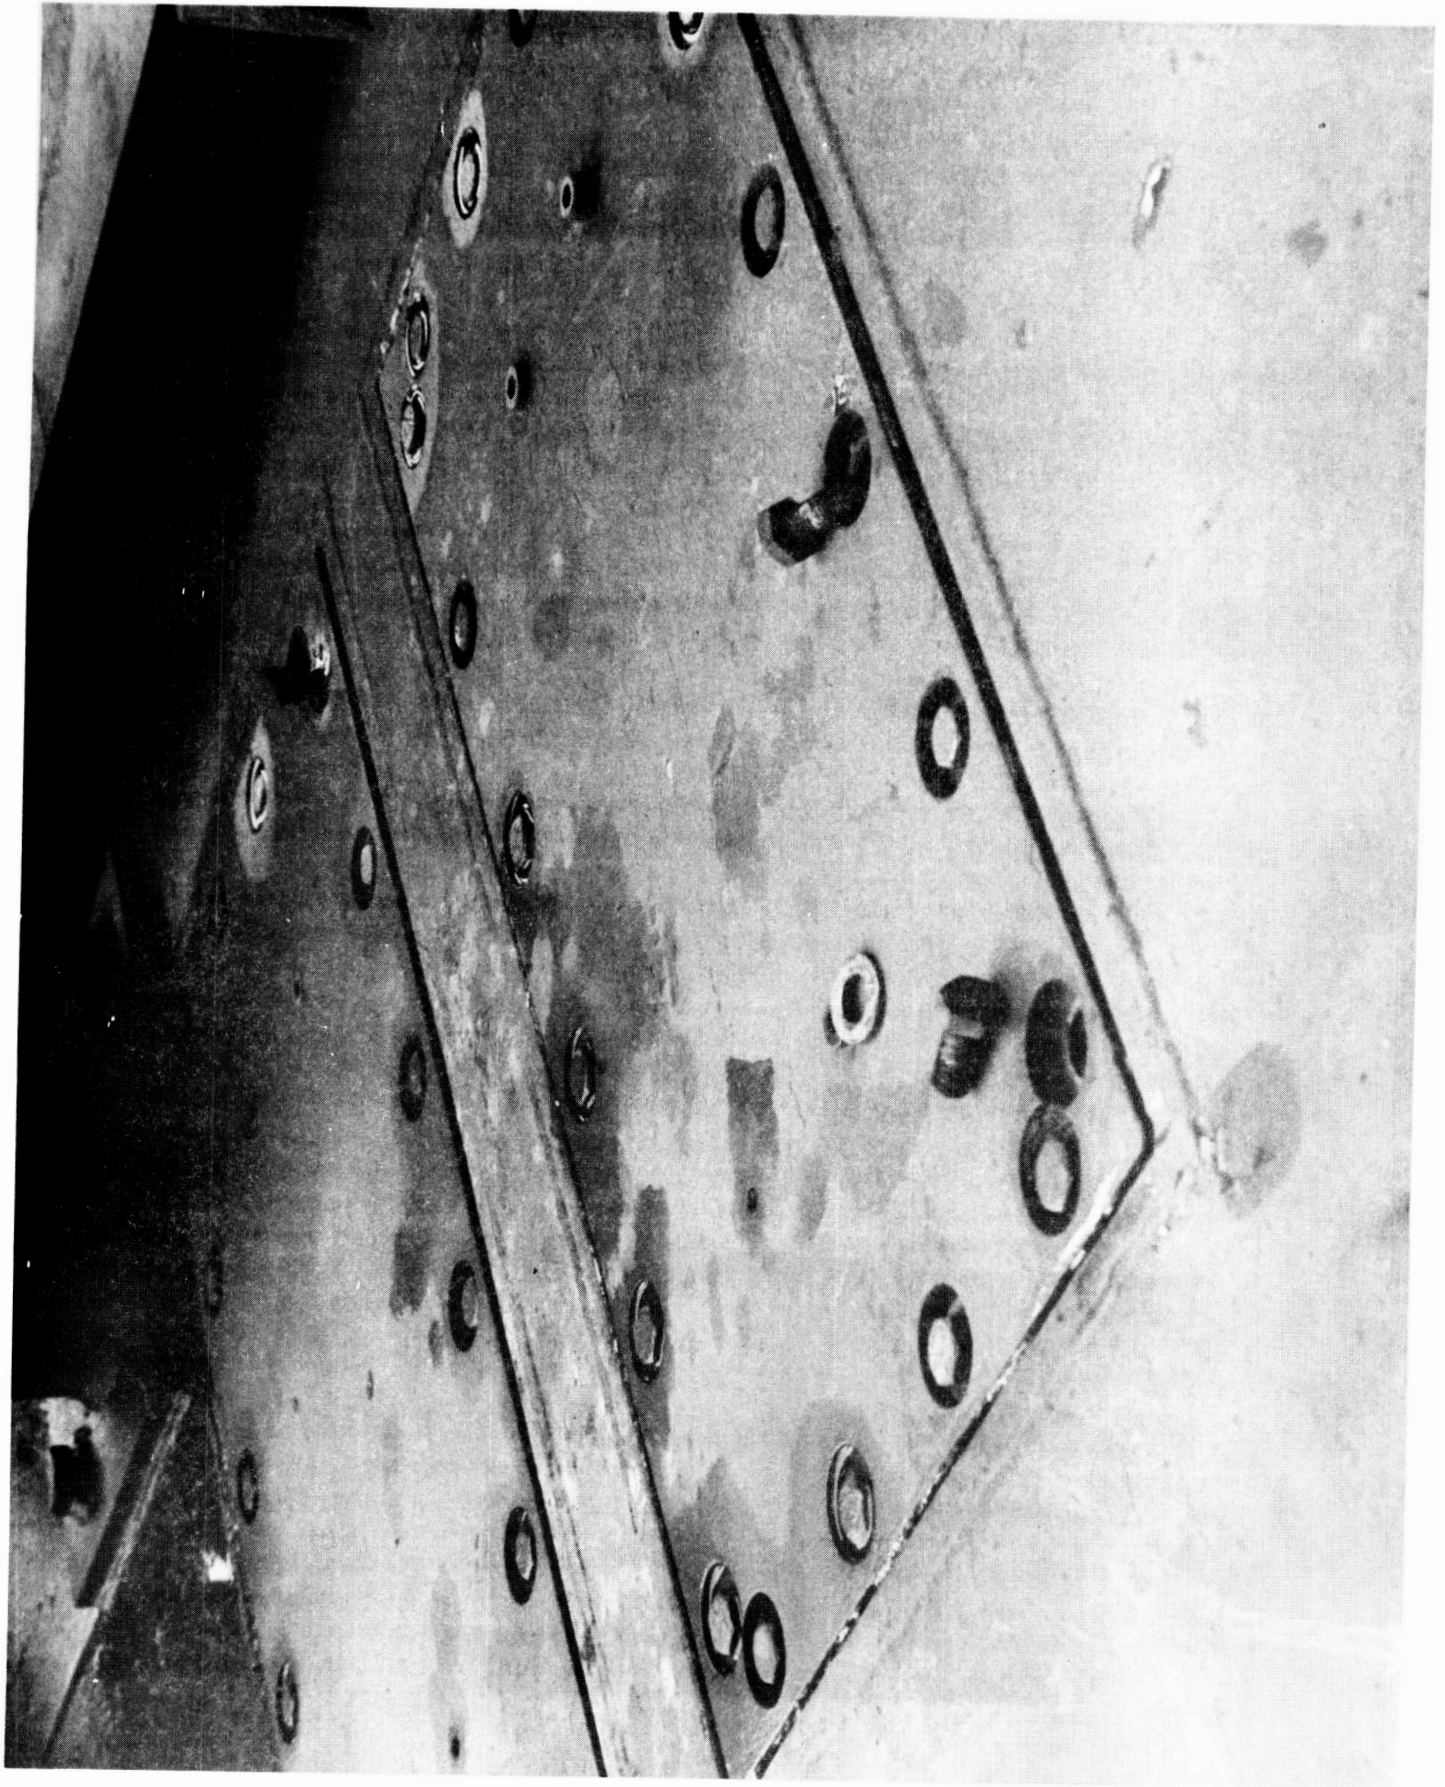
LOOSE ACCESS PLATE BOLTS ON MLP DECK

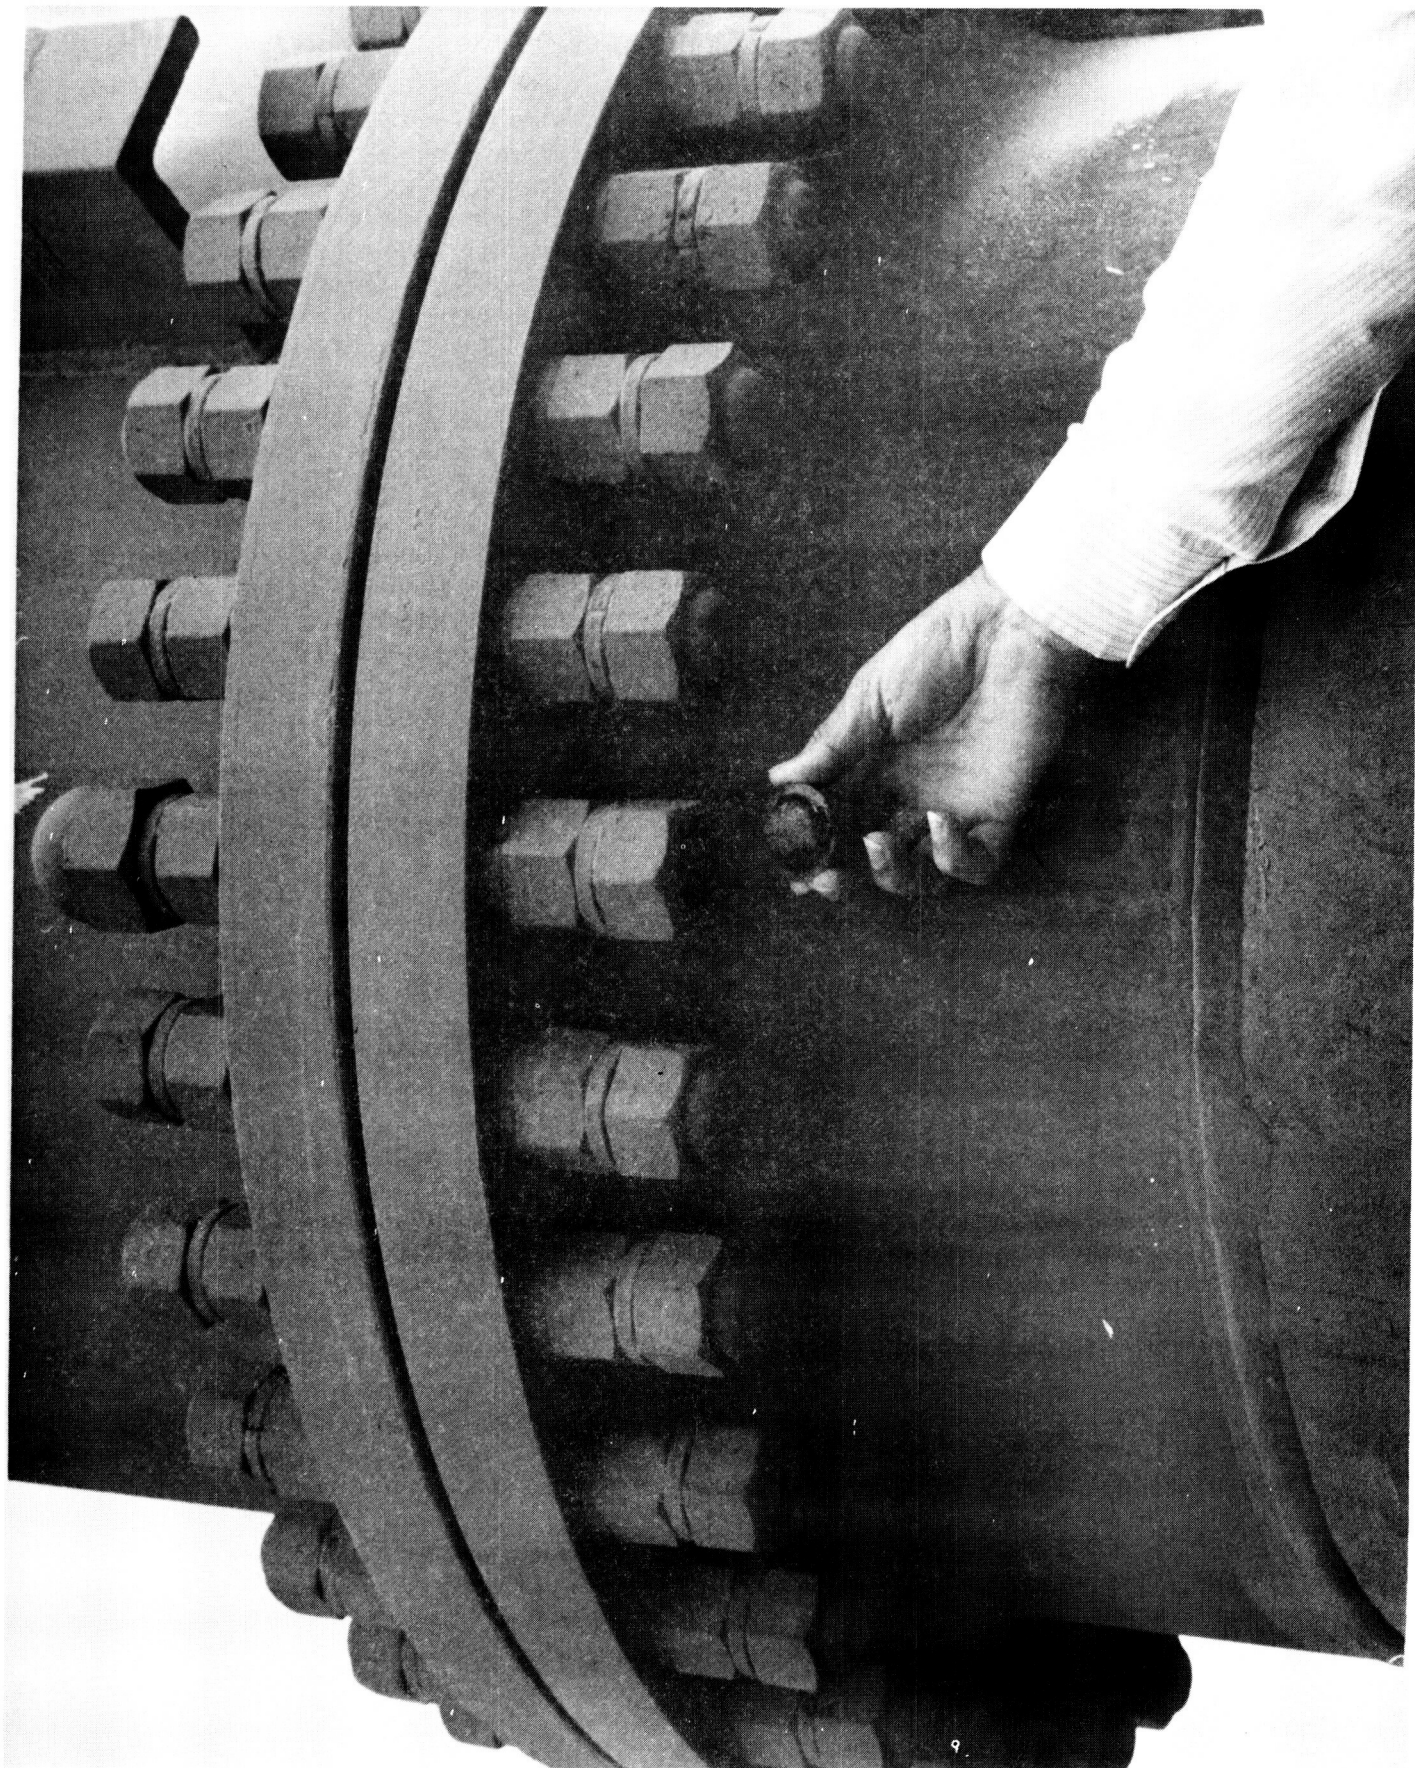
A few bolt dome caps were loose on the MLP deck rainbirds. Subsequent checks revealed about 30 caps were loose enough to possibly be dislodged by the SRB plume. These caps were removed prior to launch.

LOOSE DOME CAP ON SOUND SUPPRESSION SYSTEM RAINBIRD BOLT

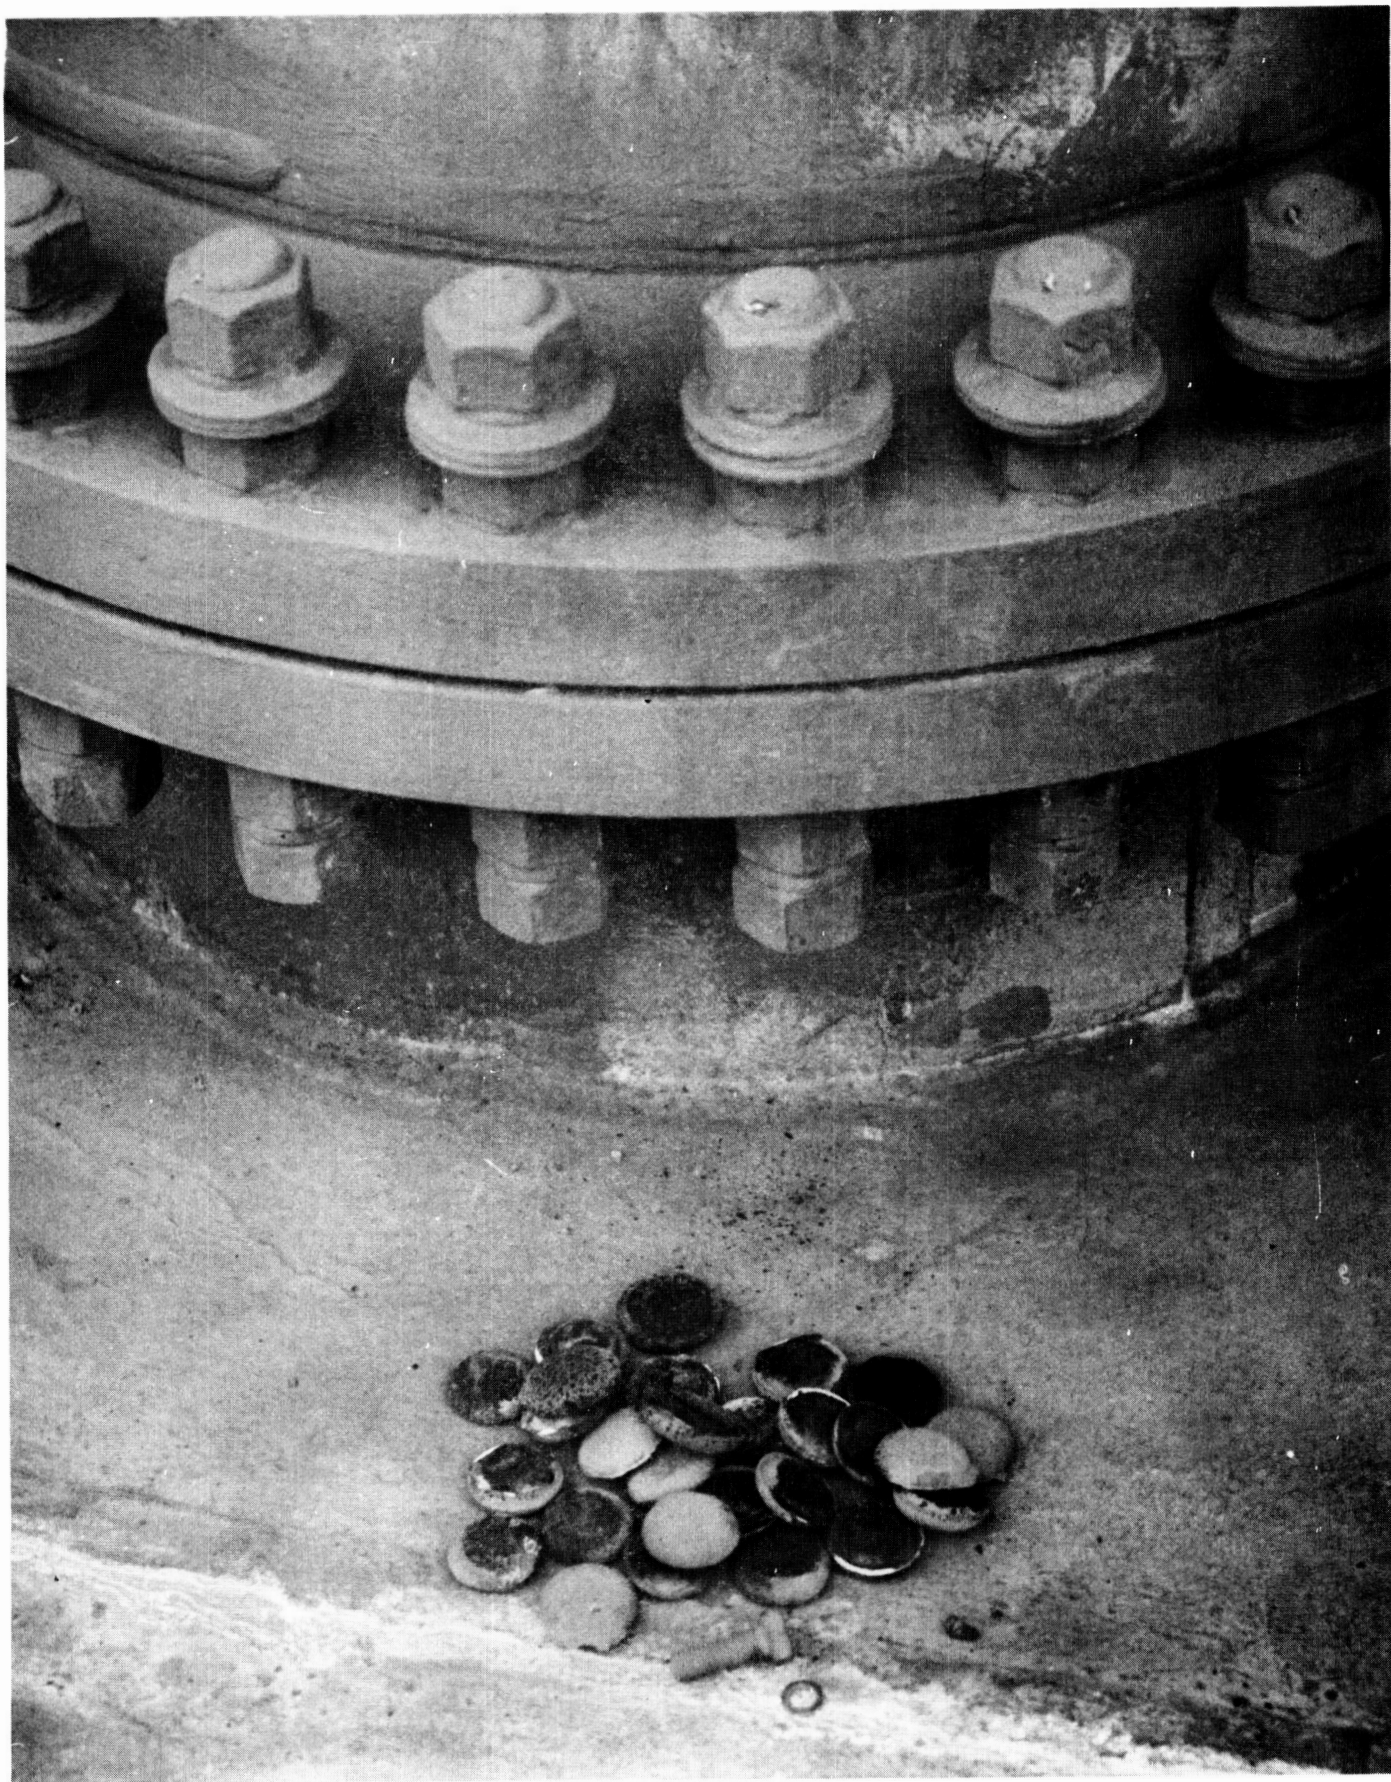
COLLECTION OF DETACHED BOLT DOME CAPS

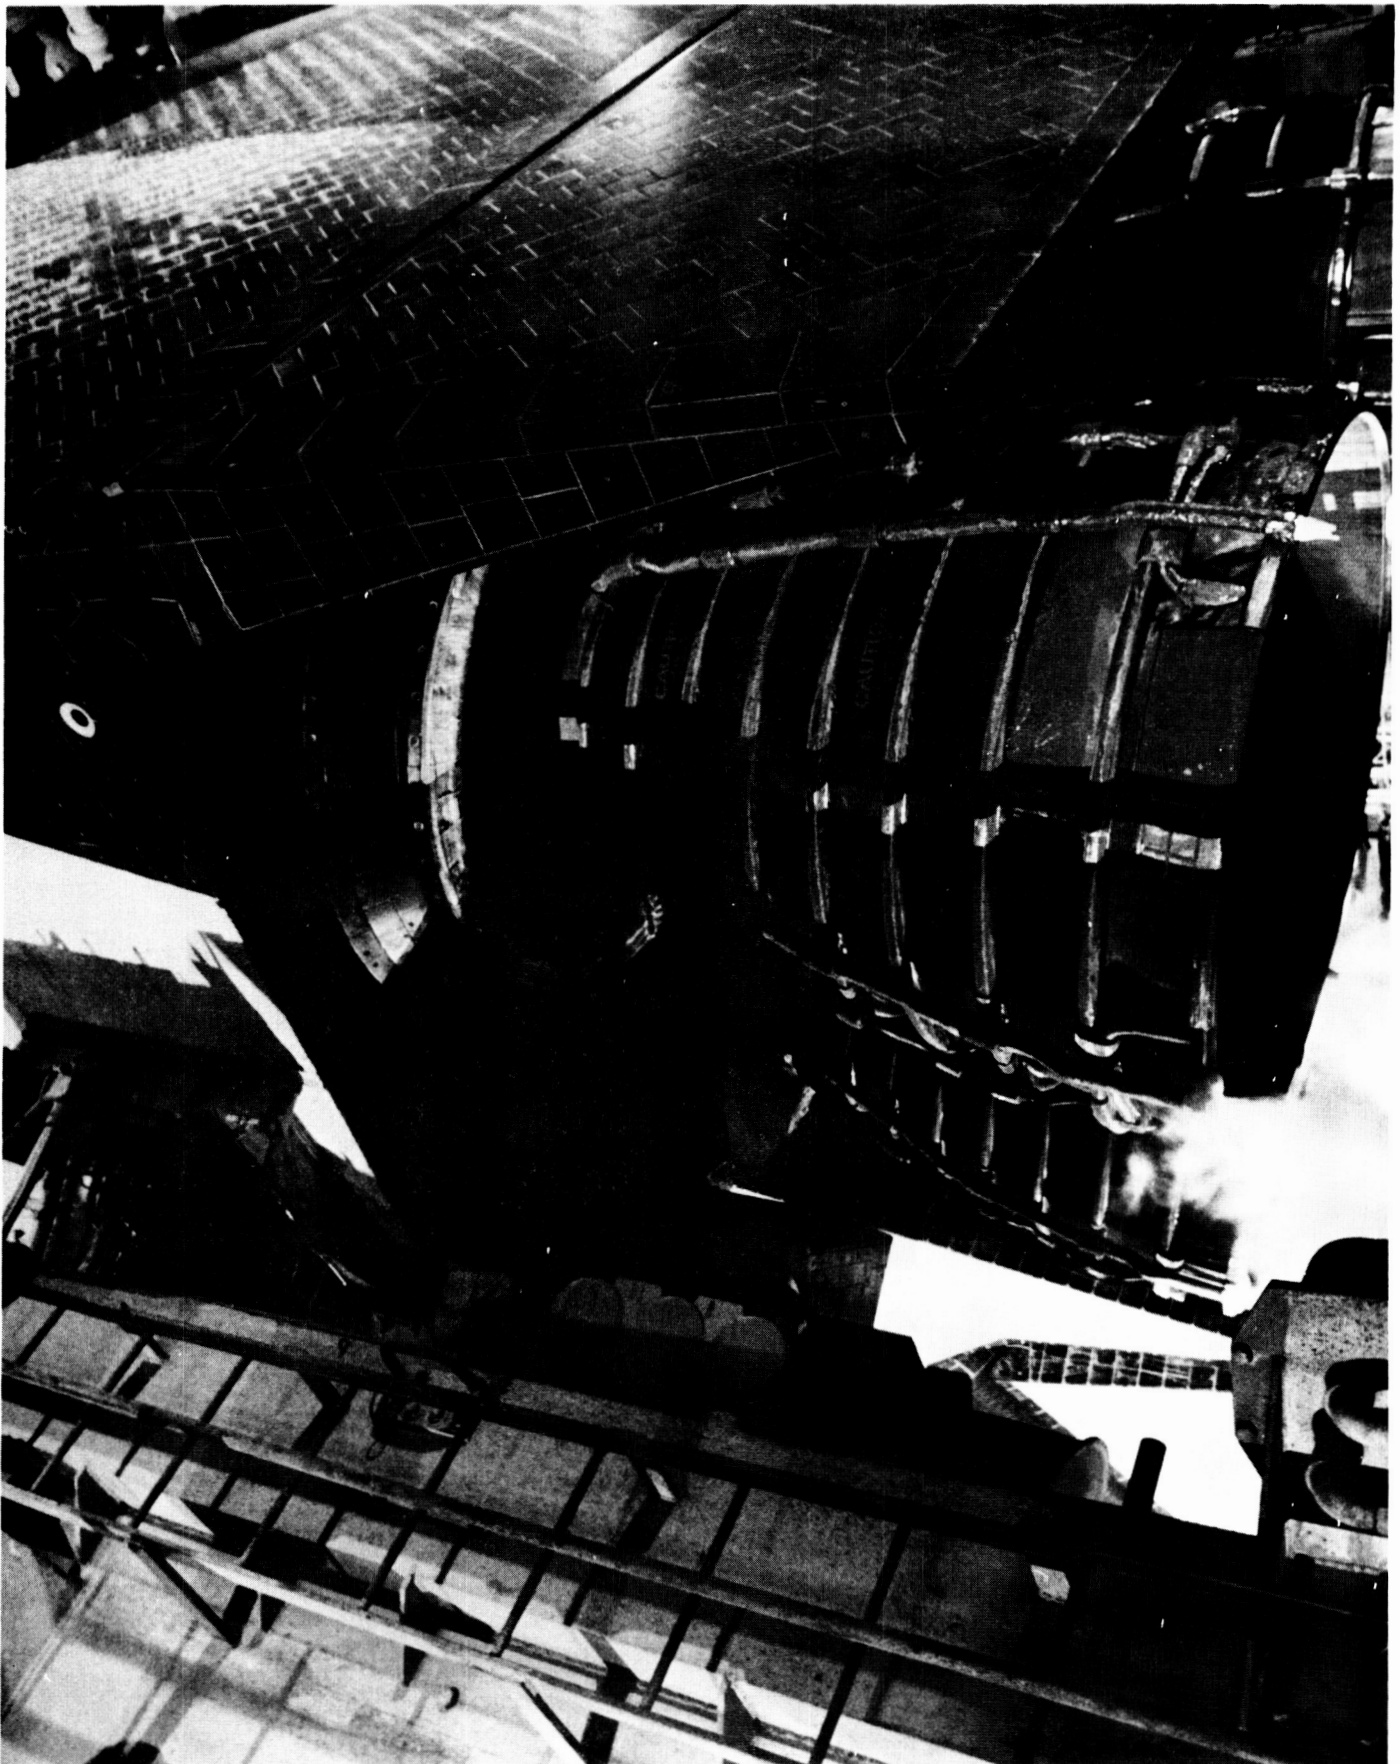
TYPICAL ICE/FROST BUILD-UP ON SSME NOZZLE GOX VENTS.
NO ICE/FROST ON SSME ENGINE MOUNTED HEAT SHIELD

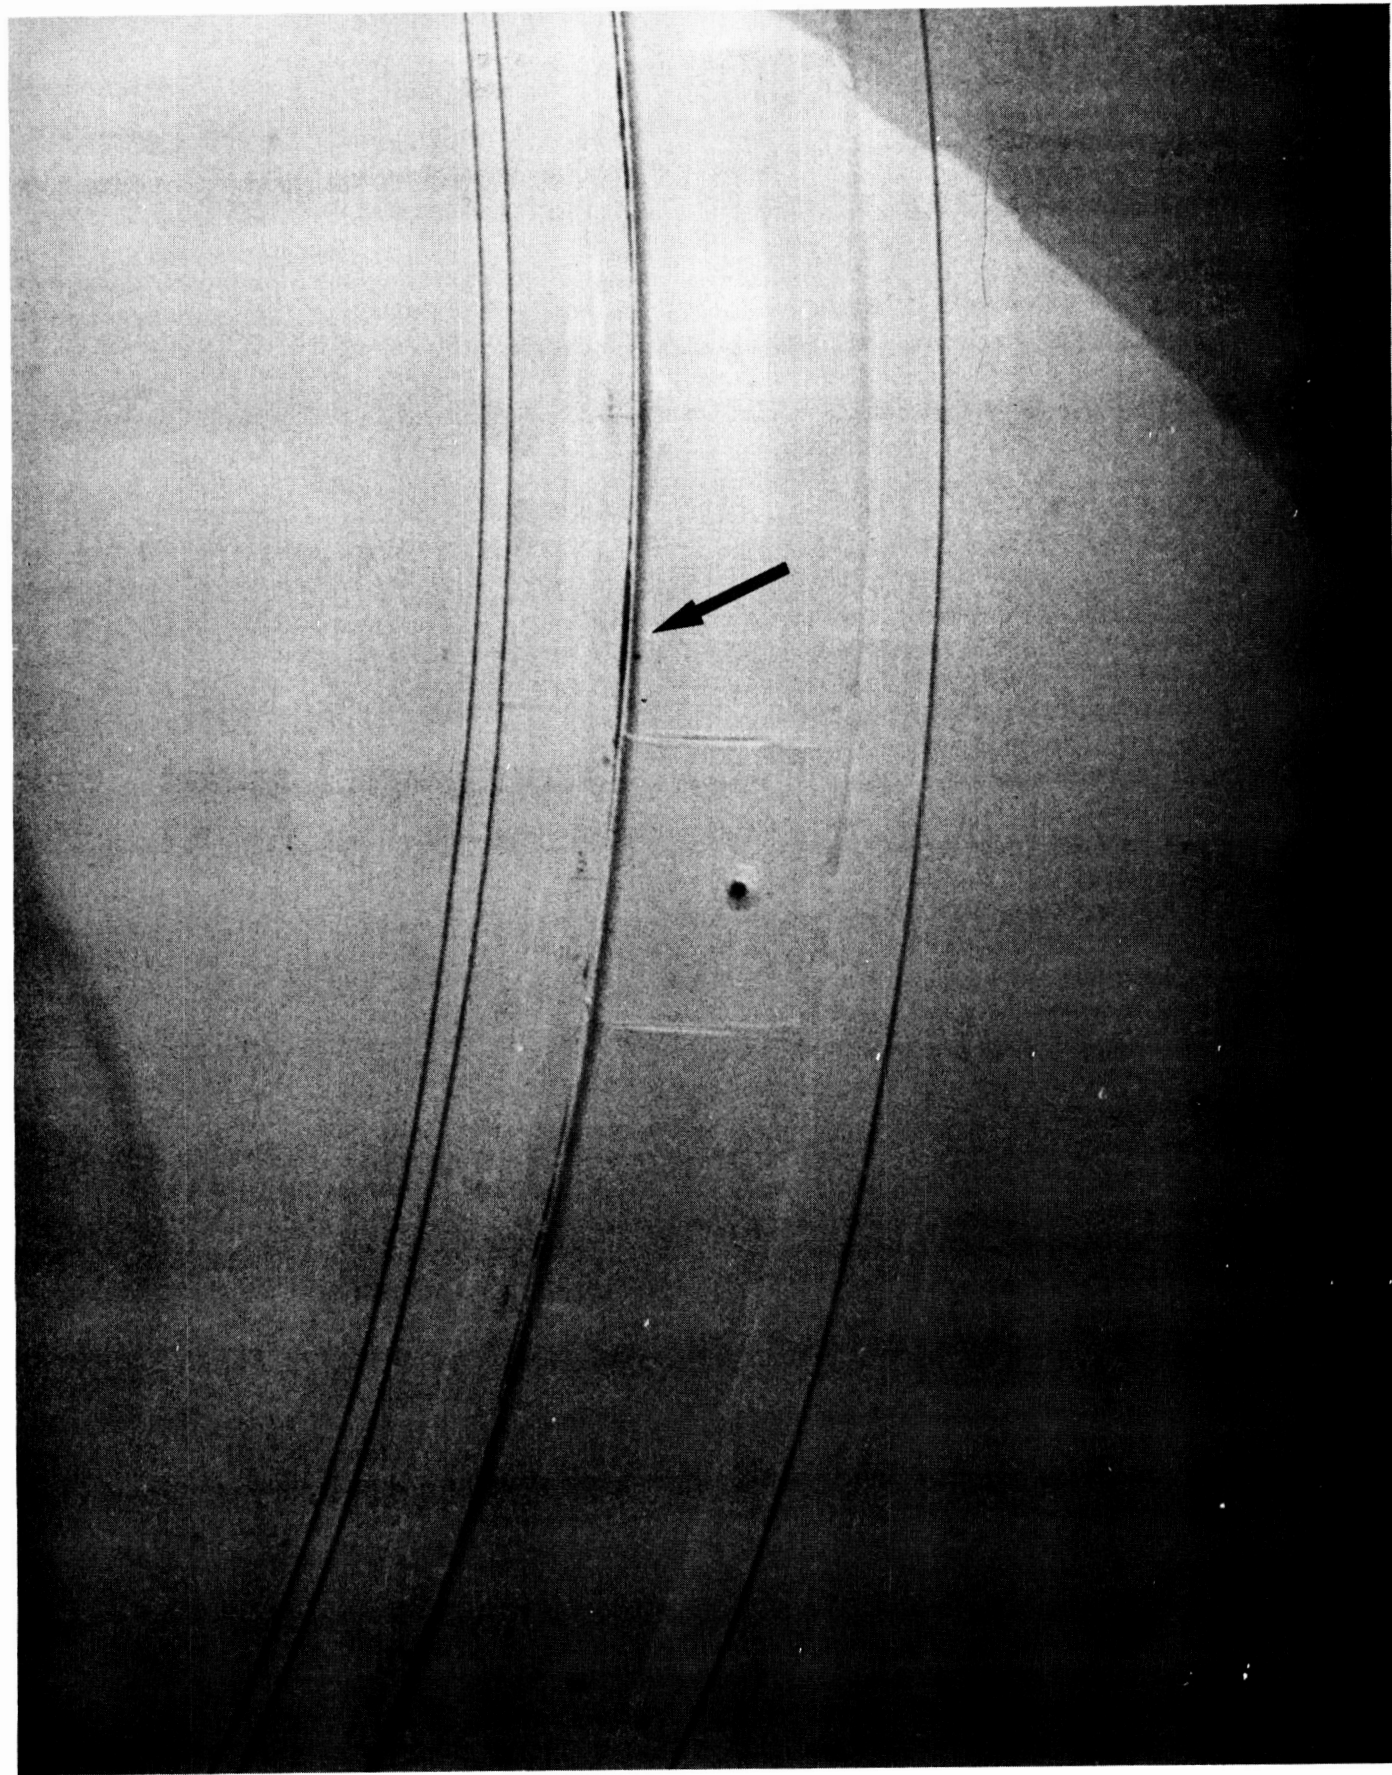
SUSPECT DEBOND OF CLOSEOUT CORK ON LH SRB CENTER FIELD JOINT.
DETERMINED TO BE AREA OF MISSING WHITE HYPALON PAINT.

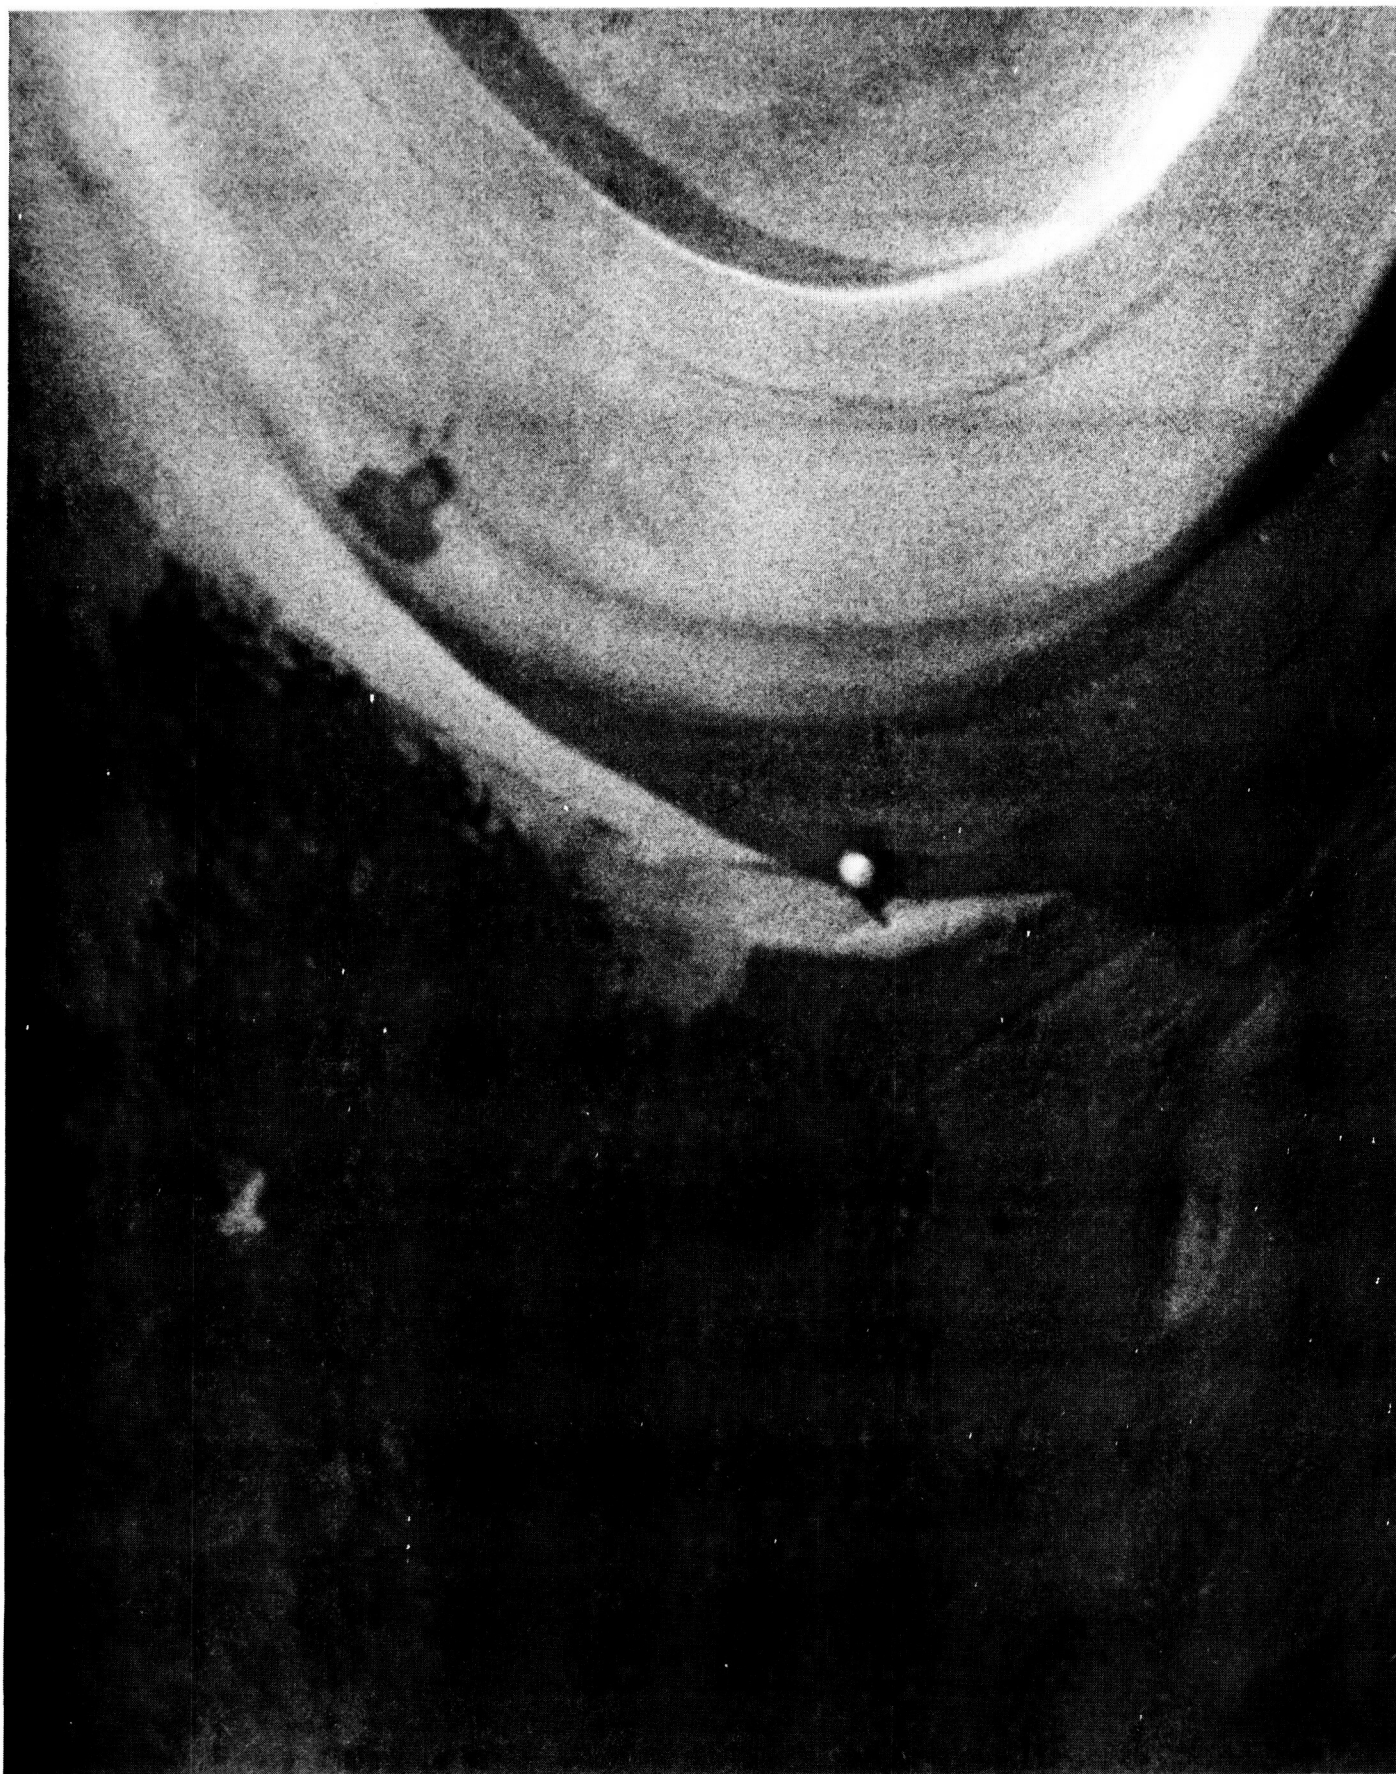
Two small ice/frost balls were observed on the LH2 tank. The first was located on the -Z third hardpoint and had a diameter of approximately 1/2 inch. The second was located on the aft dome manhole closeout and was approximately 3/4 inch in diameter. Both of these conditions are acceptable per NSTS-08303.

FROST BALL ON ET LH2 TANK AFT DOME MANHOLE COVER CLOSEOUT

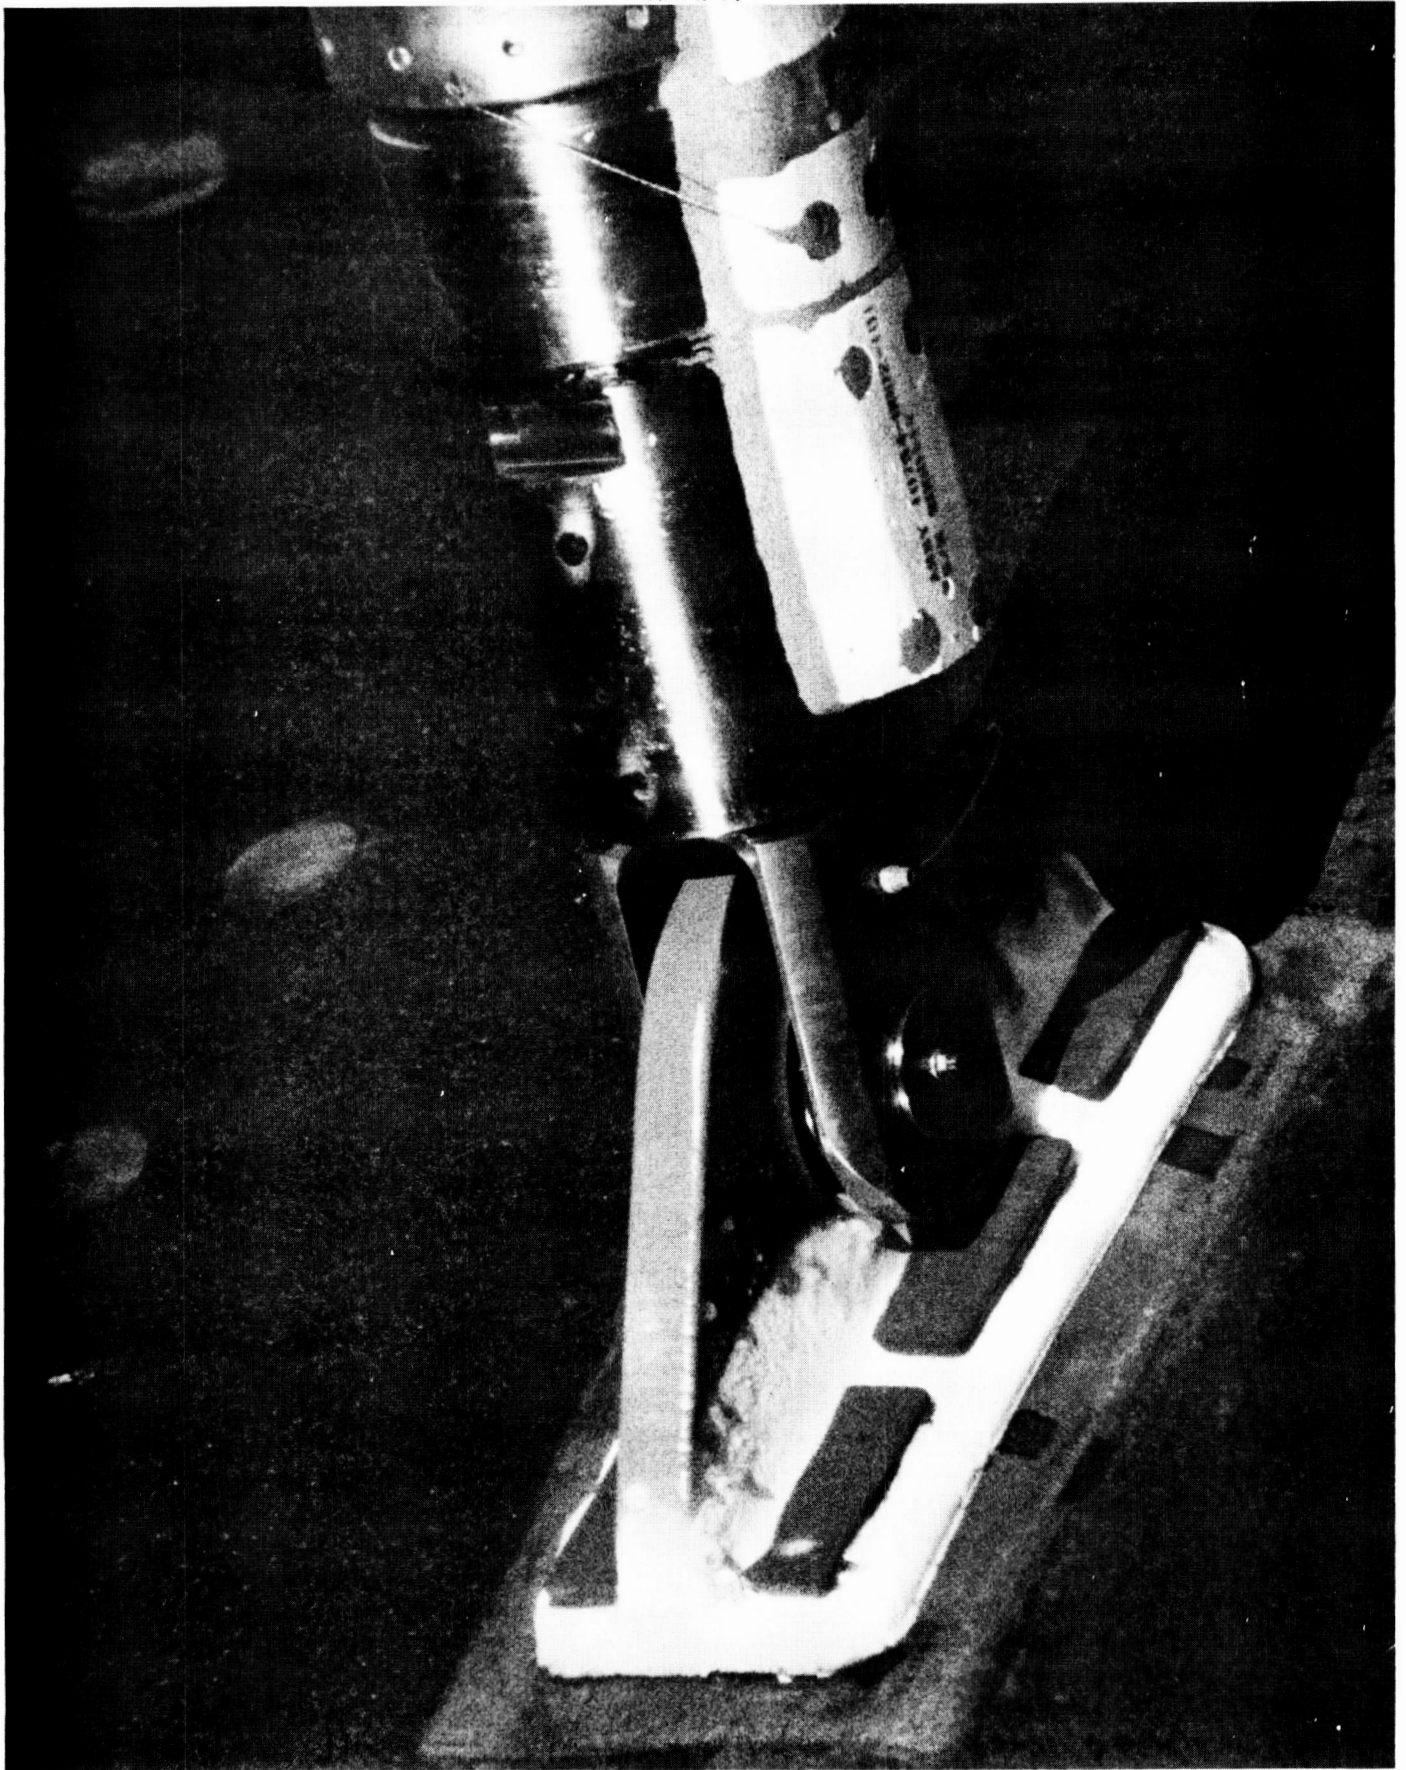
Ice/Frost covered the lower EB fittings outboard to the strut pin hole with condensate dripping from the rest of the fitting. The EB struts were dry and were not covered by ice.

TYPICAL FROST BUILD-UP ON INBOARD SIDE OF -Y ET/SRB AFT STRUT
FITTING. CONDENSATE IS PRESENT ON OUTBOARD SIDE OF FITTING.

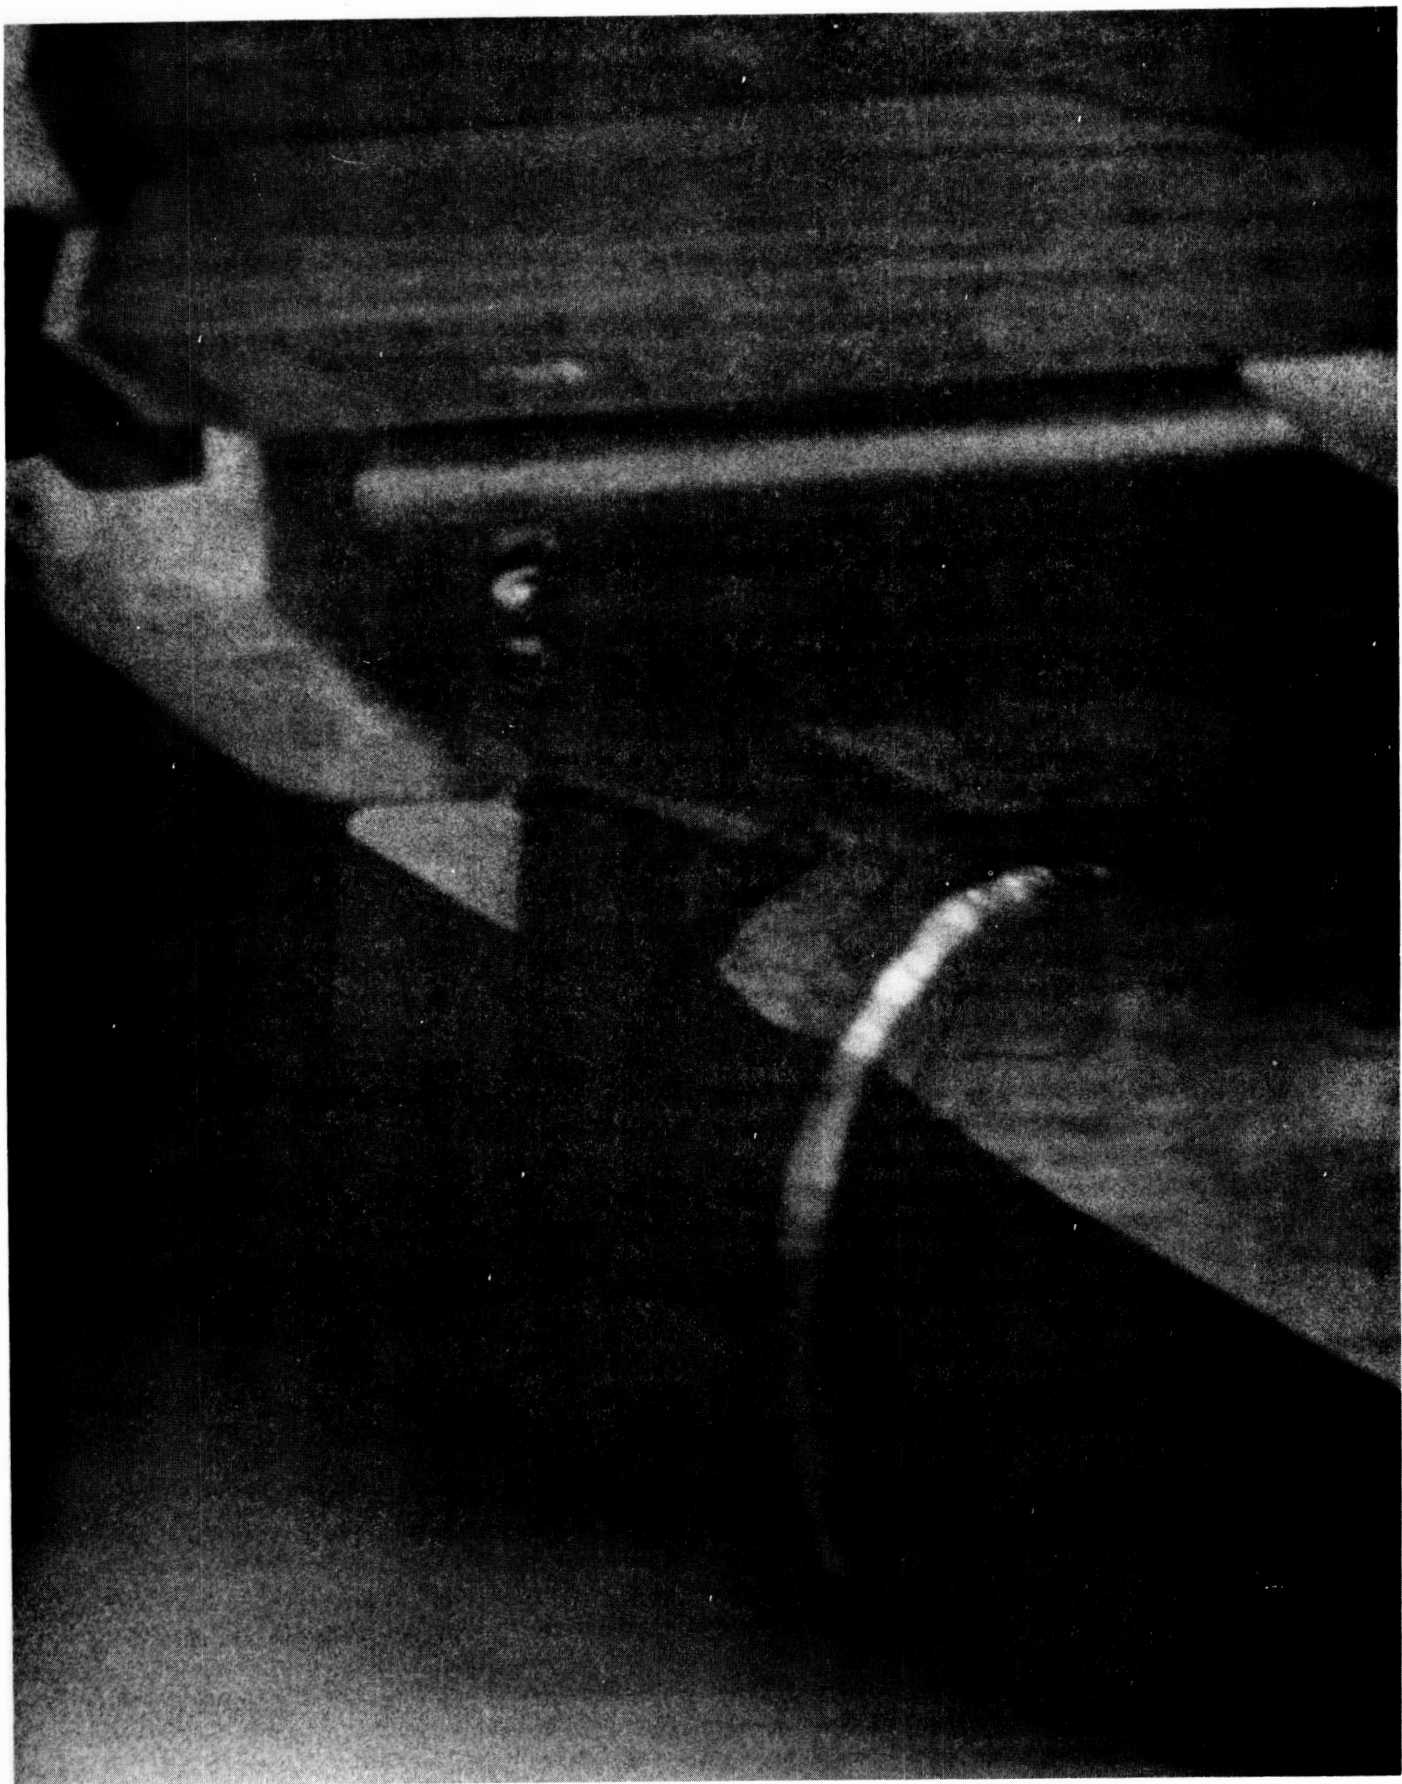
ICE/FROST ACCUMULATION IN LO2 FEEDLINE BELLOWS XT 1973

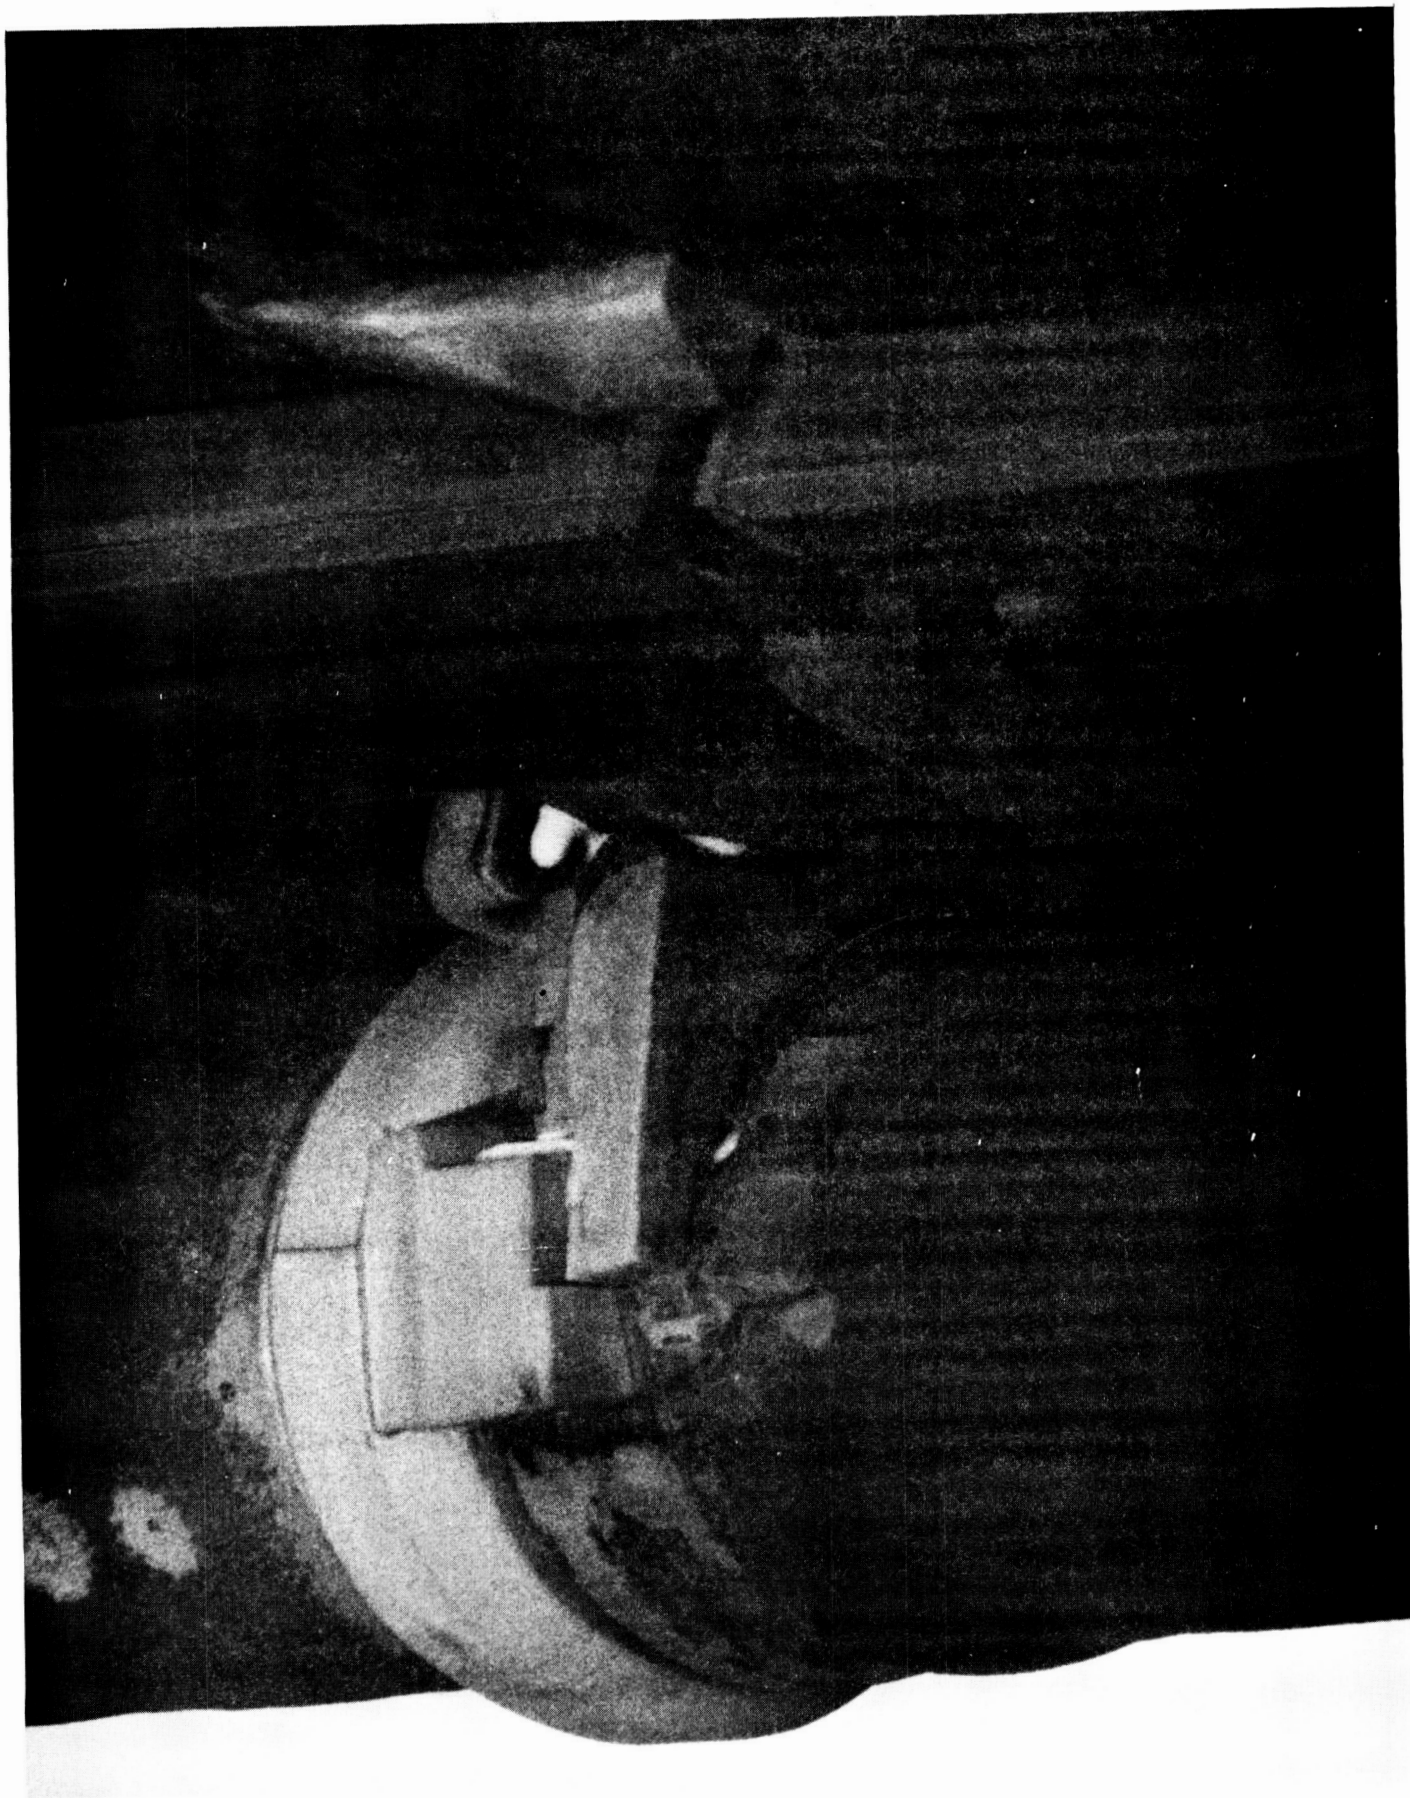
ICE/FROST ACCUMULATION IN LO2 FEEDLINE SUPPORT BRACKET XT 1623
